Structural behaviour of bamboo-reinforced foamed concrete slab containing polyvinyl wastes (PW) as partial replacement of fine aggregate

Efe Ikponmwosa ^a, Christopher Fapohunda ^{b,*}, Olamiposi Kolajo ^a, Otu Eyo ^a

^a Department of Civil and Environmental Engineering, University of Lagos, Nigeria

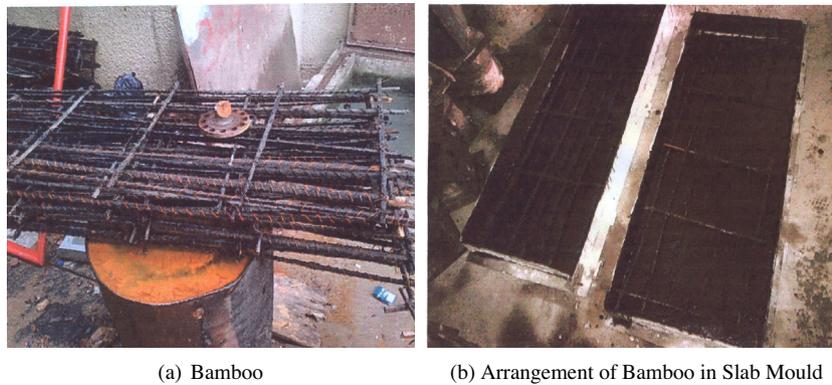
Figure 1 Arrangement of bamboo splits prior to placement and in slab mould.

The bamboo strips, 10 mm × 10 mm in section, were arranged inside the mould with a cover of 20 mm. The slab specimens were designed for bamboo reinforcement with the minimum area reinforcements of 0.24% bh (where b = width per m length, and h = total depth) as per BS 8110 (1997) by treating the bamboo strips as low yield reinforcement. The same bamboo strips of 10 × 10 mm section were used for both main and distribution. However, for the main bar, the spacing of the bamboo strips was at 150 mm, while the spacing of 250 mm was used for the distribution. The details of the bamboo strips reinforcement arrangement are shown in Figs. 1 and 2.

Binding wire was used to hold the bamboo together in the form of mesh. The tensile strength of the bamboo strips was 95 N/mm². Foamed aerated concrete was then cast in the specimens, air-cured and tested at 7, 14, 21, and 28 curing days. The sand fraction of the mix was replaced up to 30% at an interval of 5%. Experimental investigation included monitoring of cracks and measurement of central deflection for load increment of 5 kg/cm². Application of loads was gradual until

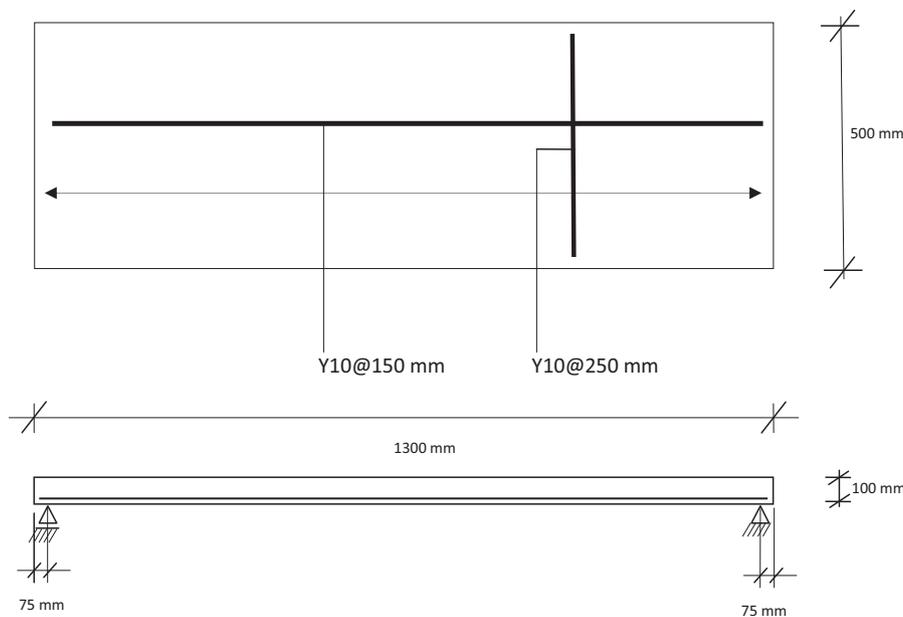
Figure 2 Typical reinforcement details for the slab specimens.

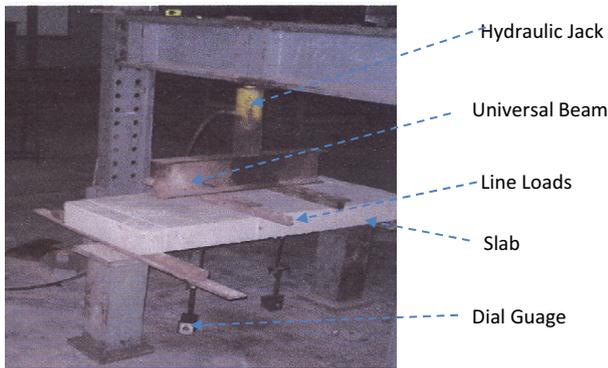
Figure 3 Testing arrangement for the slab.

failure occurs, and deflections at some intermediate load readings were also noted. The gradual application of the load was achieved with the use of a hydraulic jack and the deflection produced was recorded on the two dial gauges placed at the two critical points at the underside of the slab. The slab was simply supported with a span of 1300 mm. A fixed roller support is positioned at one end and a movable roller support at the other end. The concentrated central loading is spread by an I-section and rollers into line loads at one-third of the span to the right and left of the fixed and movable roller supports (Fig. 3).

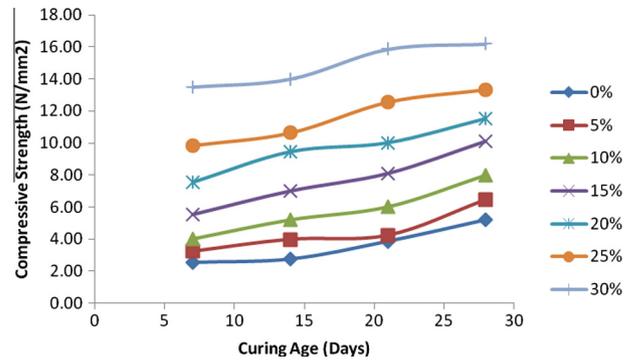
Figure 4 Effect of curing age on the compressive strength on the foamed aerated concrete with PW as partial replacement of sand.

The densities of the foamed aerated concrete specimens ranged between 1454.82 and 1999.11 kg/m³. These values fell within the range of densities targeted for this work, which is necessary if the results of this investigation are to be considered as valid for foamed aerated concrete. It can however be noticed from Table 1 that the density of all the specimens increased with curing age at the replacement level of sand with polyvinyl waste (PW). From Table 1, it is particularly noticed that the density increased with the increase in the percent of sand replaced with PW. It can thus be inferred that the PW has a densifying effect on the matrix of the material, and this densification increased as the percent of its replacement with sand increased. The results of the compressive strength tests on the cube specimens are shown in Figs. 4 and 5. From Fig. 4, it can be seen the compressive strength increased with curing ages. This increase can be attributed to continuous hydration of cement which made it possible for the development of the strength-forming C-S-H gel.

Also it was observed that the distance “ x ” from the support from which the crack propagates decreased as the percentage replacement of sand in the mix with PW was increased. This might be due to increased bending resistance at higher replacement levels resultant from improved compressive strengths (Figs. 4 and 5). Though the specimens still exhibited brittle failure, but less abruptly with increase in the level of partial replacement of sand with polyvinyl wastes.

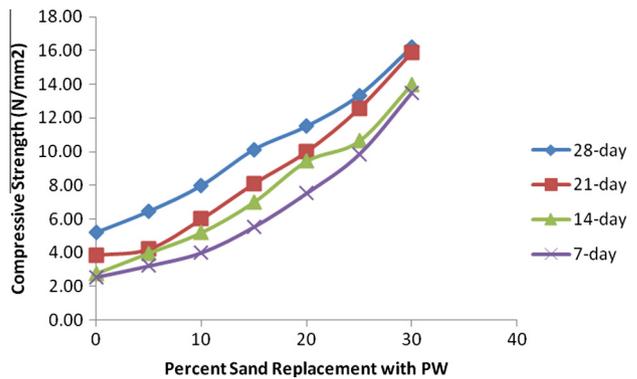
Figure 5 Effect of partial replacement of sand with polyvinyl waste (PW) on the compressive strength on the foamed aerated concrete.

the process will stop, leading to loss in strength development (Neville, 2003). Further, from Fig. 5, it can be particularly noted that the compressive strength increased with increase in the sand replacement with PW at all the curing ages. Relative to the control, all the specimens developed higher compressive strength, and it increased as the content of PW increased. This can be explained by the fact the PW used has some fine-grained particles. The chemical properties of the PW (Appendix A) are suggestive of pozzolanic characteristics (with a combined silica, alumina and ferrite content of above 51.45%). The presence of CaO in substantial quantity (30.11%) also suggests reactivity potential to produce C-S-H gel.

Thus the presence of fine grain PW in the mix gave room for the PW to participate in the hydration process to yield extra strength for the foamed aerated concrete. The increase in the compressive strength increased with the increase in the sand replacement with PW.

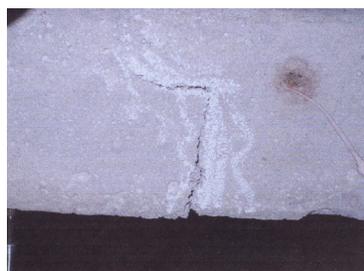
(a) The Specimen at Failure

Figure 6 Schematic representation of failure modes of slab specimens containing polyvinyl waste (PW) as partial replacement of sand.

The specimens did behave this way. The control specimens (0% PW) failed in diagonal tension. This is manifested by the development of crack at the support (under side of the slab specimens) along the whole width of the slab specimens, and propagated diagonally in the direction of the applied load. The failure was very brittle. However, for all other specimens having polyvinyl waste (PW) as partial replacement of sand, failure was a combination of bending moments and shear forces. The crack began at a distance from the support at the tension zone across the width of the slab, and grows vertically into the slab specimens' cross section (Fig. 6) as the load was increased before final failure.

All the specimens failed due to the extension of the crack into the compression zone. Astill and Martin (1981) and Arya (2004) described this mode of failure as shear bending failure. The crack widened as the loading was increased.

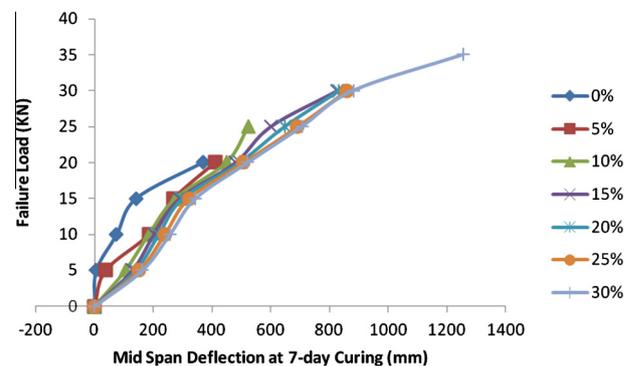
Figure 7 Load–deflection curve for slab specimens at 7-day curing.

The load–deflection curves of the slab specimens at all the replacement levels of sand with polyvinyl wastes (PW) at the curing ages considered are shown in Figs. 7–10.

It can be observed in Figs. 7–10 for all the curing ages that the pre-cracking stage where the curves are expected to be linear are clearly absent, suggesting the inelastic behaviour of the material. The fact that stress–strain relationship of bamboo is non-linear (Rahman et al., 2011; Sevalia et al., 2013) may have contributed to the non-linear behaviour of the specimens.

At all the replacement levels, the load-carrying ability of the slab specimens increased with increase in sand replacement with polyvinyl waste (PW) at all the curing ages.

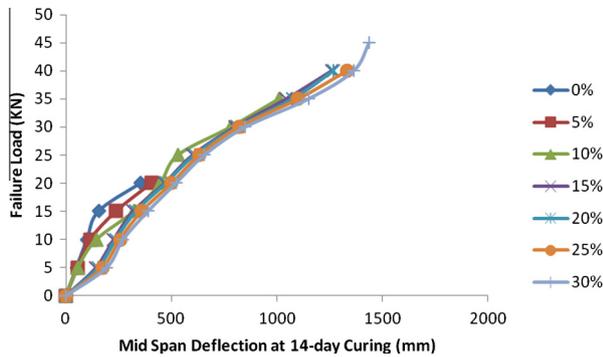
Figure 8 Load-deflection curve for slab specimens at 14-day curing.

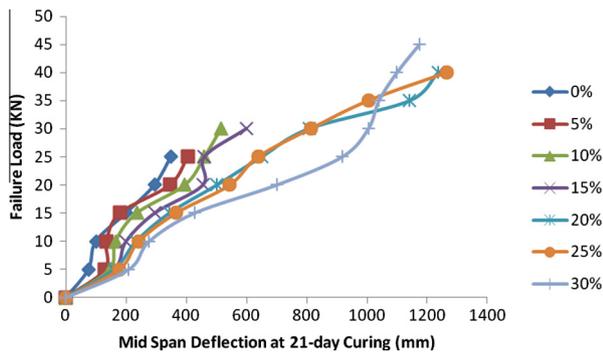
Figure 9 Load-deflection curve for slab specimens at 21-day curing.

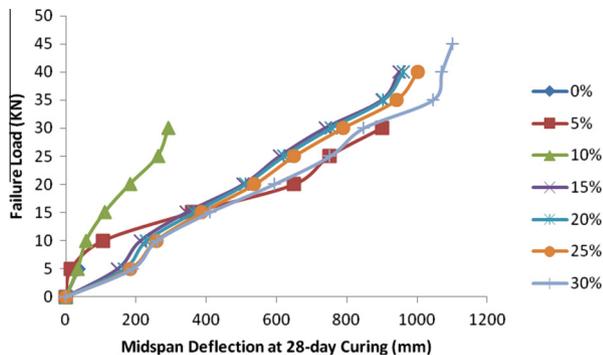
Figure 10 Load-deflection curve for slab specimens at 28-day curing.

increased at all the curing ages. For example, at 10% sand replacement with polyvinyl waste, the deflections at 20KN were 480, 467, 455, and 405 mm respectively at 7-, 14-, 21-, 28-day curing ages. The same pattern was exhibited at all the other replacement levels. The reason for improved deflection characteristics can be explained from the expression for calculating the deflection in which the denominator is the term EI (the flexural rigidity) of the material. According to Nageim et al. (2010), increase in the value of the flexural rigidity means a decrease in deflection. While the geometrical properties I remaining constant in this study, the value of E cannot be said to be constant, as it usually varies with materials (Nageim

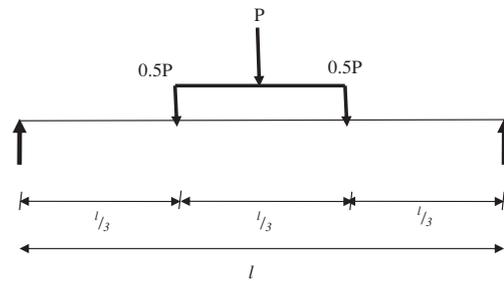
Figure 11 Structural configuration for third point loading.

For the structural and loading configurations for a two-point loading arrangement used for this investigation shown in Fig. 11, the Davison and Owens (2005) gave the ultimate mid span bending moment (experimental) as:

$$M_{max} = \frac{Pl}{3} \tag{1}$$

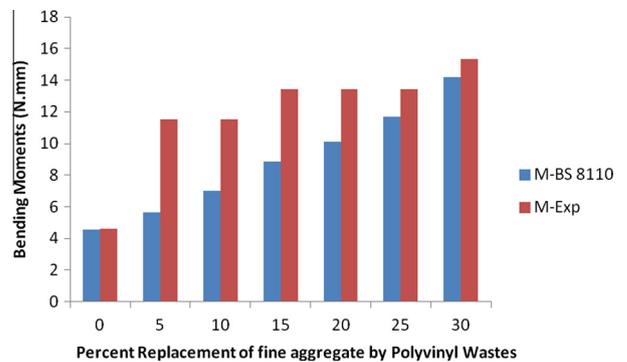
Figure 12 Comparison of theoretical and experimental moments.

Eq. (2) suggests that the ultimate moment of resistance depends on the properties of the concrete materials and geometry of the beam. The values of the bending moments using Eqs. (1) and (2) for the slab specimens at all the replacement levels of sand with polyvinyl wastes are shown in Fig. 12.

From Fig. 12, it can be observed that the experimental moments are consistently higher than the theoretical moments (BS 8110) at all the replacement levels of sand with polyvinyl waste. The higher bending moments obtained experimentally is to be expected. This is because Eq. (1) used for its computation depends on the failure loads. The failure load in turn is a function of the resistance provided both by the concrete materials and the bamboo reinforcement. This is unlike BS 8110 equation in which the contribution of bamboo reinforcement to the values of the bending moment was not part of the parameters of the equation. The bending response of the slab specimens improved as the percentage of sand replaced with polyvinyl wastes increased.
